INDOOR AIR QUALITY ASSESSMENT

**Department of Transitional Assistance
755 Main Street
Haverhill, Massachusetts**

Prepared by:
Massachusetts Department of Public Health
Bureau of Environmental Health Assessment
August, 2000

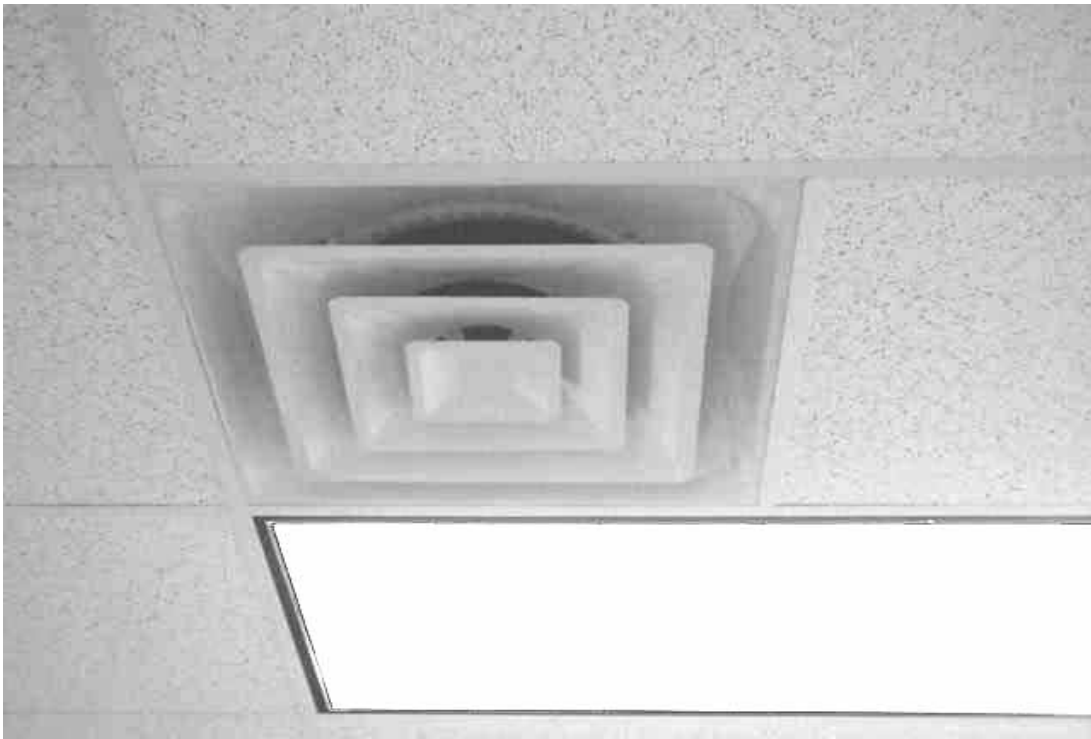
Picture 1

A heating, ventilation and air conditioning (HVAC) system provides ventilation. Fresh air is provided by rooftop-mounted air-handling units (AHUs) and distributed through ducted, ceiling vents located throughout the building (see Picture 1). Exhaust ventilation is provided by ceiling-mounted exhaust grilles, which return air to the AHUs (see Picture 2). This system was operating during the assessment. Restroom ventilation

Ceiling-Mounted Air Diffusers Noted Throughout the Department of Transitional Assistance

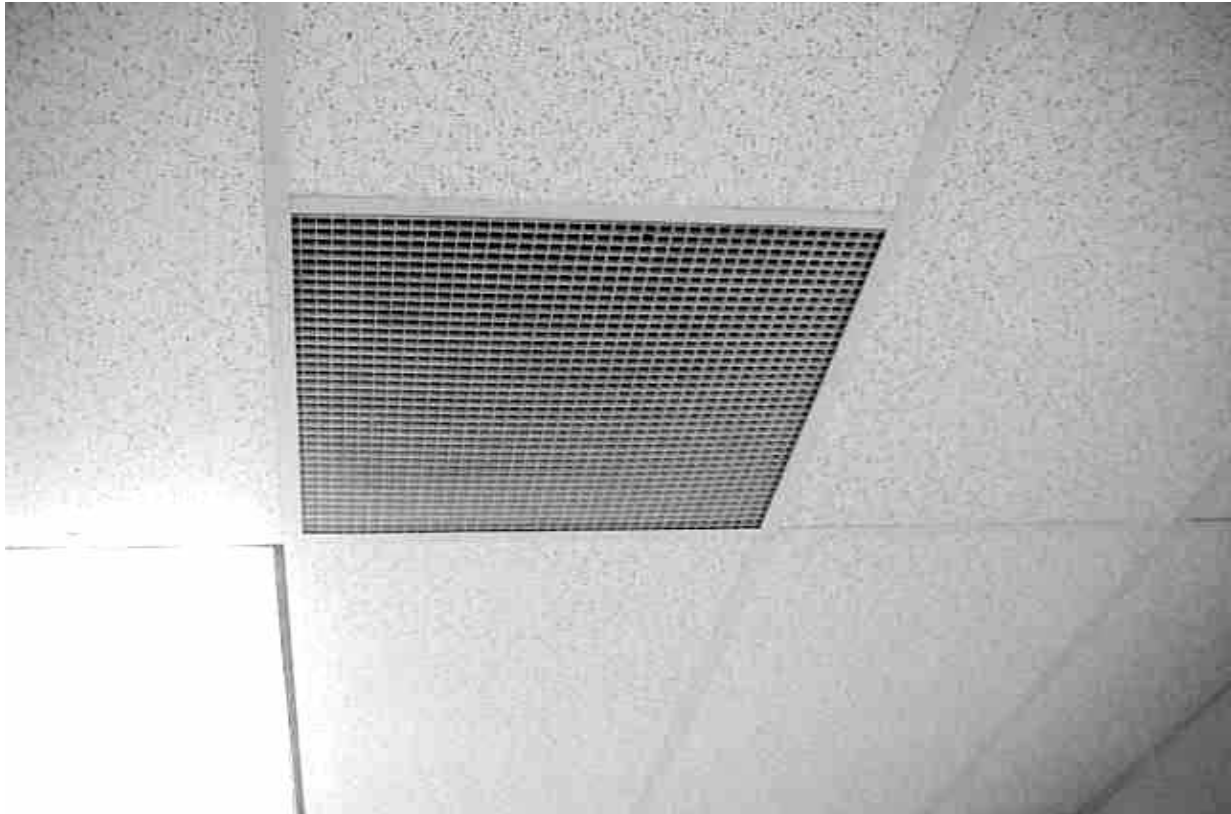
Picture 2

Return Air Grate Noted throughout the Department of Transitional Assistance

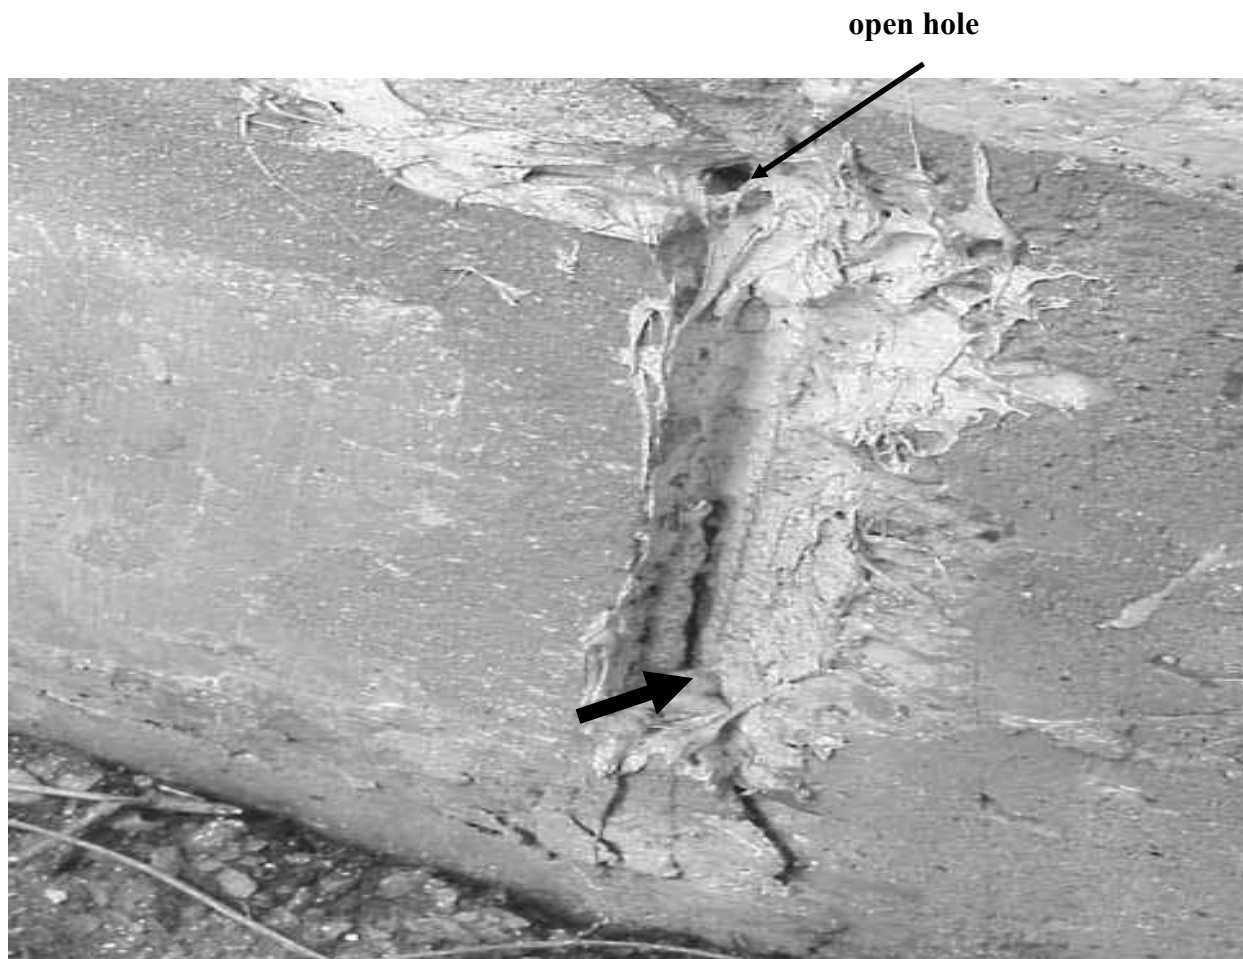
Picture 3

A number of cracks in the exterior wall/foundation were noted along the West (residential) side of the building (see Pictures 3-4). While several of these cracks appeared to have been sealed with a caulking material, others were not. In some cases holes were noted in the waterproofing material. These conditions are breaches of the building envelope and can provide a means for water entry into the building. Repeated

Separation Noted in Exterior Wall/Foundation (Residential Side of Building) Note Holes and Spaces Despite Attempts to Seal

6. Repair and/or replace thermostats as necessary to maintain control of comfort.
7. Repair cracks on the exterior wall/foundation of the building to prevent water penetration.

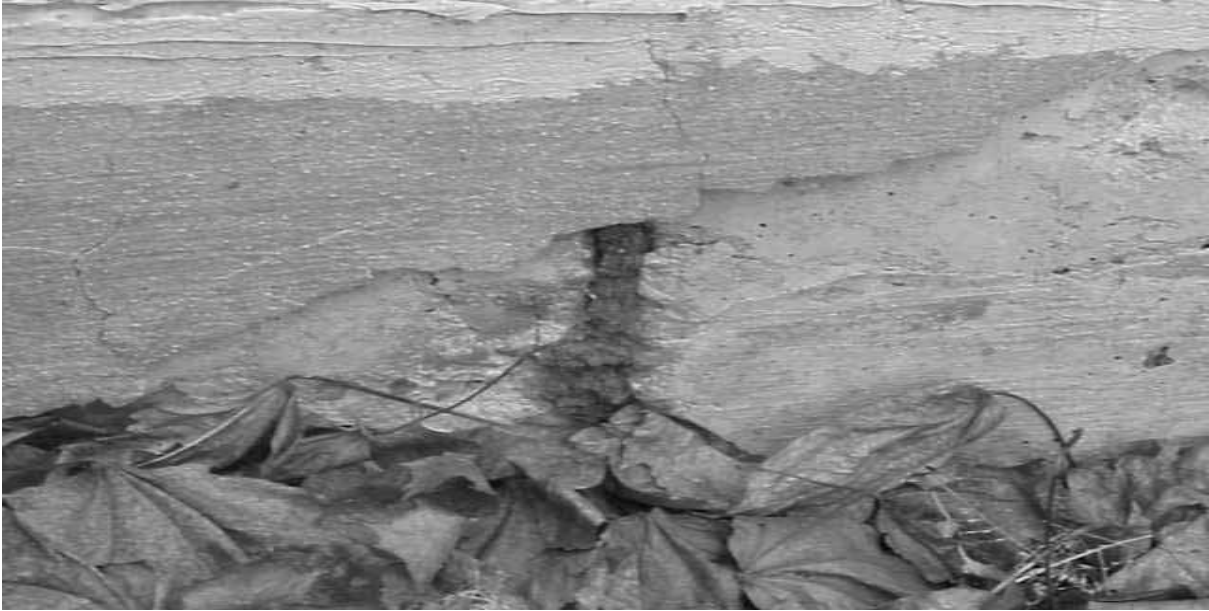
Picture 4

Separation Noted in Exterior Wall/Foundation (Residential Side)

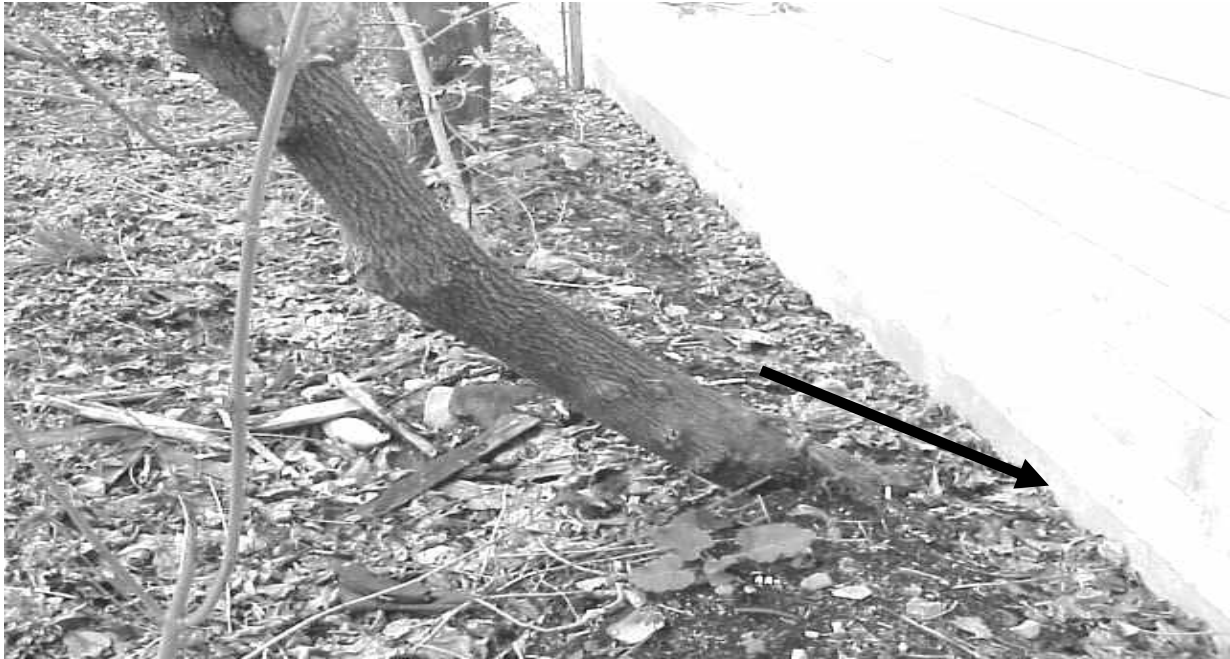
Picture 5

Also noted on the residential side of the building were trees/stumps growing close to the foundation/exterior wall (see Pictures 5-6). The growth of roots against the exterior walls of the building can bring moisture in contact with wall brick and eventually lead to cracks and/or fissures in the foundation below ground level, which can breach the integrity of the building envelope and serve as a source of water penetration.

Tree Growing near Foundation of Exterior Wall (Residential Side) Note Tree Roots Appear to be Growing Towards Building (as indicated by direction of arrow)

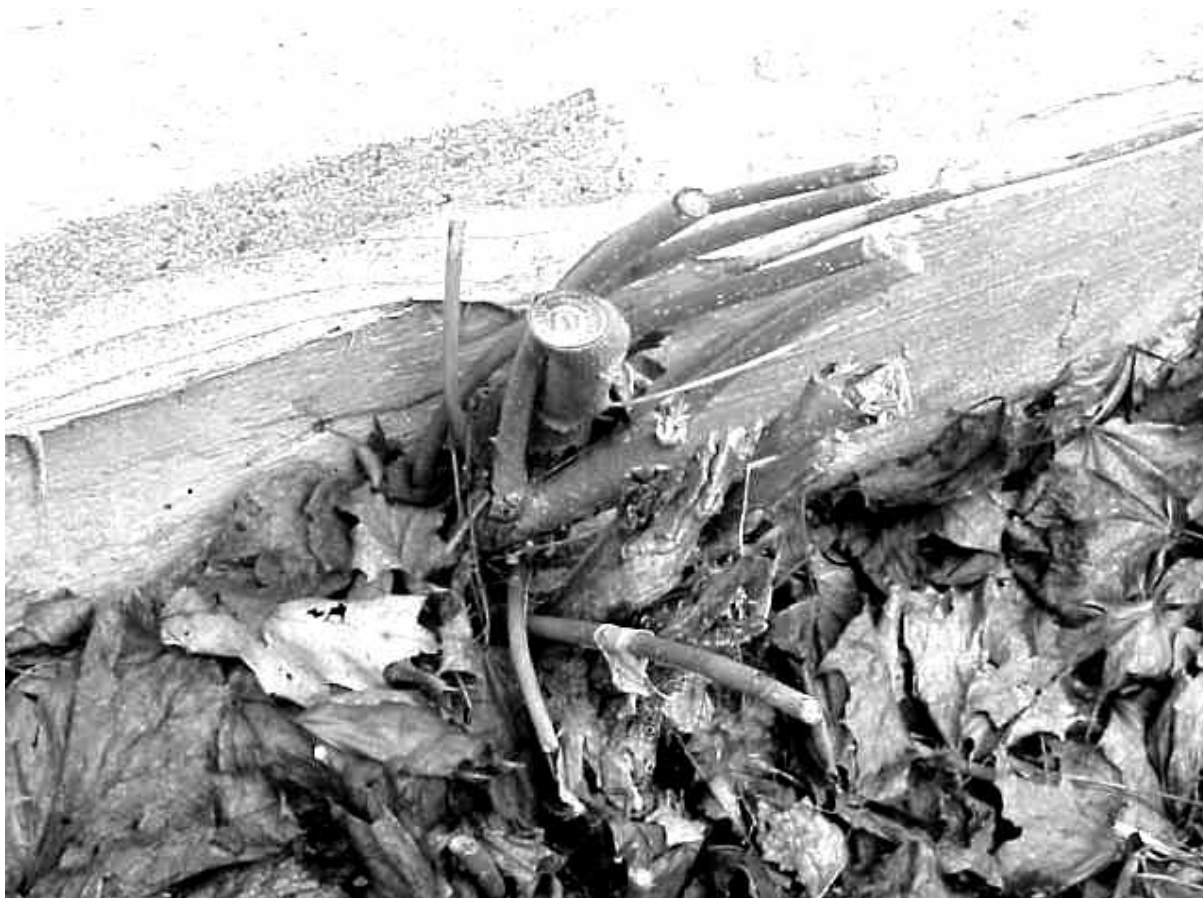
Picture 6

Tree Roots Noted near Foundation of Exterior Wall (Residential Side)

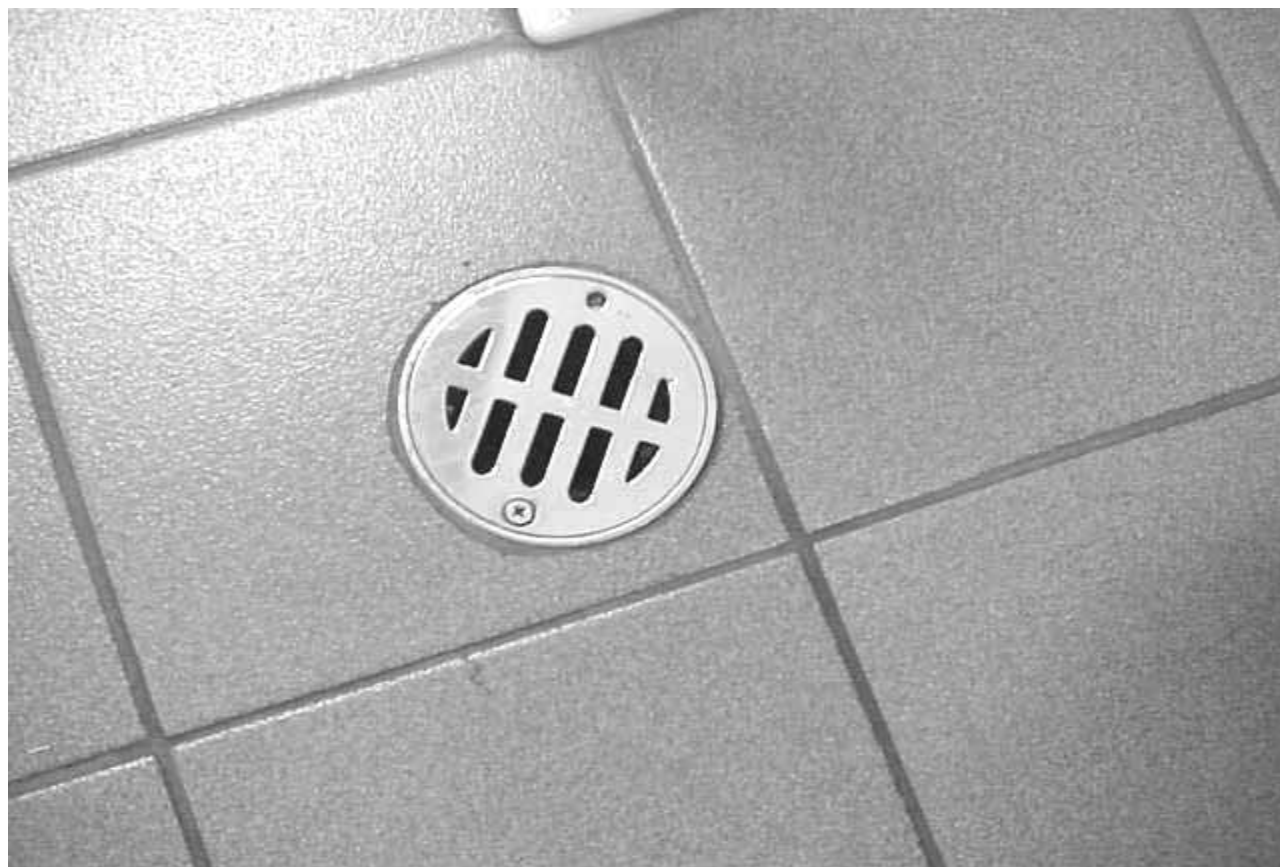
Picture 7

Floor drains were noted in restrooms (see Picture 7). Drains are designed with traps in order to prevent sewer odors/gases from penetrating into occupied spaces. When water enters a drain, the trap fills and forms a watertight seal. Without periodic input of water (e.g., every other day), traps can dry and compromise the integrity of the watertight seal. If traps dry out, sewer odors/gases can travel up the drain into occupied areas.

Floor Drain Noted in Restroom

8. Report any roof leaks or other signs of water penetration to building manager for prompt remediation.
9. Ensure photocopiers are located in a well-ventilated area.
10. Consider consulting a ventilation engineer concerning the installation of local mechanical exhaust ventilation in the custodial closet.
11. Replace missing/damaged-ceiling tiles.
12. Store chemicals and cleaning products properly.
13. Ensure water is poured into floor drains regularly to maintain the integrity of the traps.

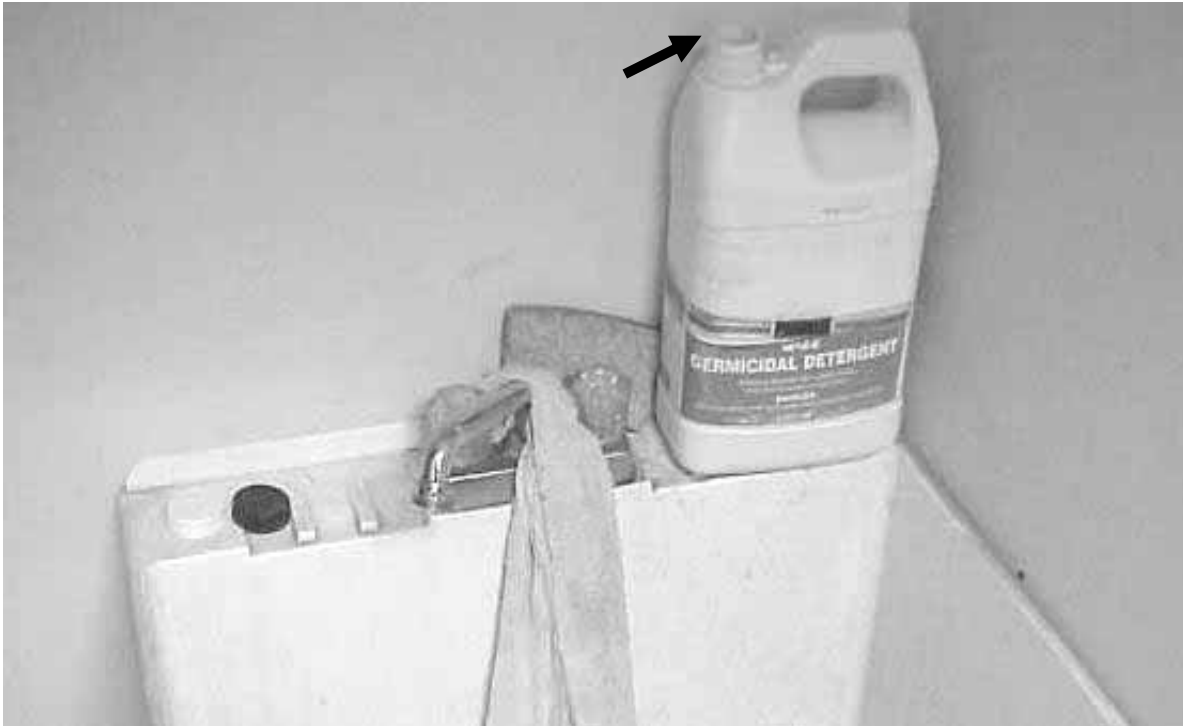
Picture 8

Located between the men and women's restrooms was an unvented custodial closet. An open container of germicidal detergent was noted on the sink in this area (see Picture 8). Also noted above the sink were missing/dislodged ceiling tiles (see Picture 9). Without mechanical exhaust ventilation odors from wet mops, cleaning supplies and other items can penetrate into adjacent areas (i.e., into the ceiling plenum through missing ceiling tiles).

Uncapped (1) Gallon Container of Germicidal Detergent Noted in Custodial Closet

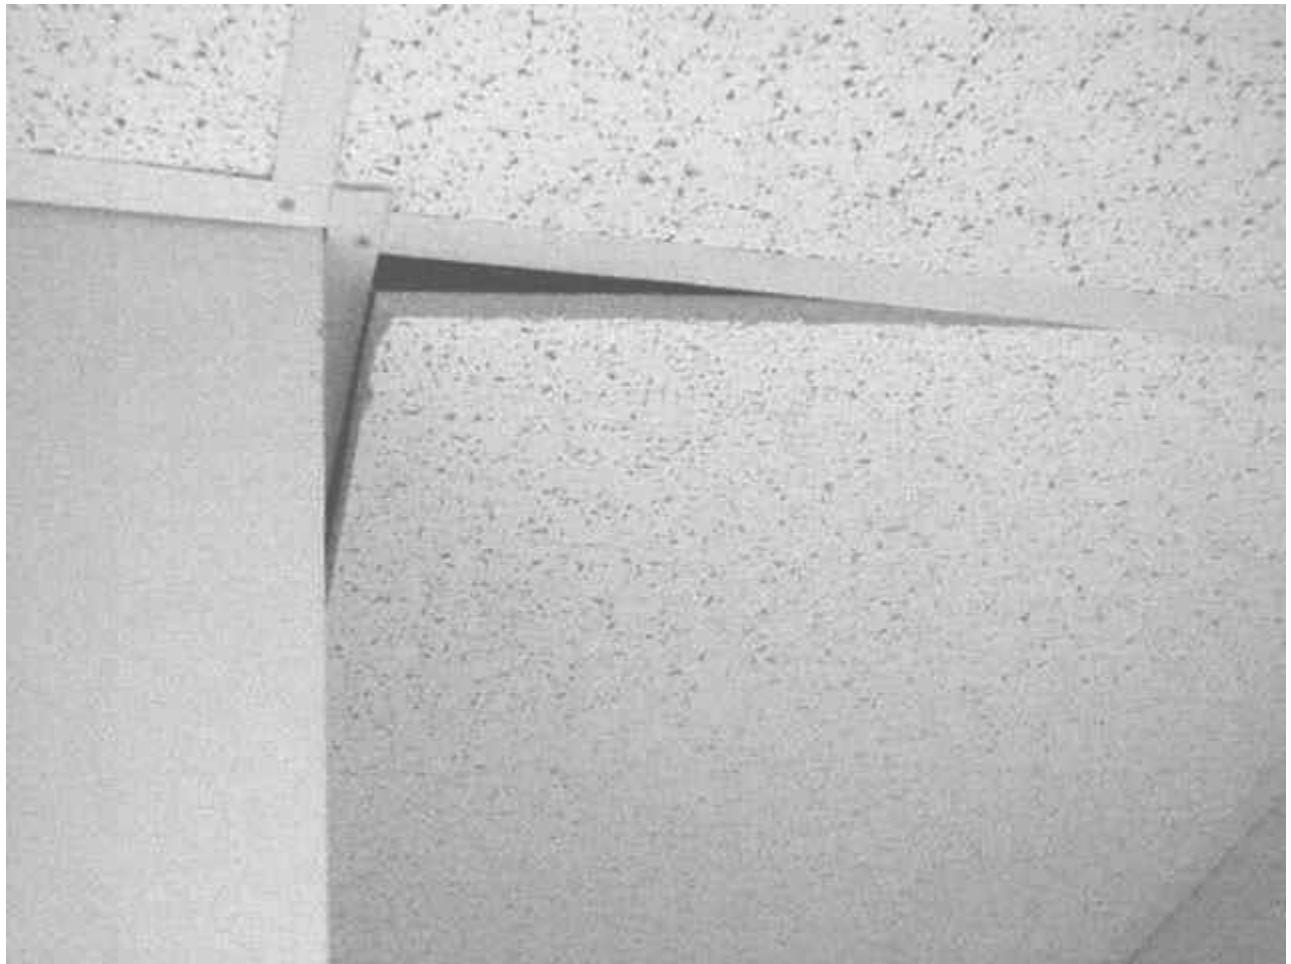
Picture 9

Dislodged Ceiling Tile Noted in Custodial Closet
